# Field Experiences With Floating Breakwaters in the Eastern United States

MISCELLANEOUS REPORT NO. 82-4

Prepared for  
U.S. ARMY, CORPS OF ENGINEERS  
COASTAL ENGINEERING  
RESEARCH CENTER

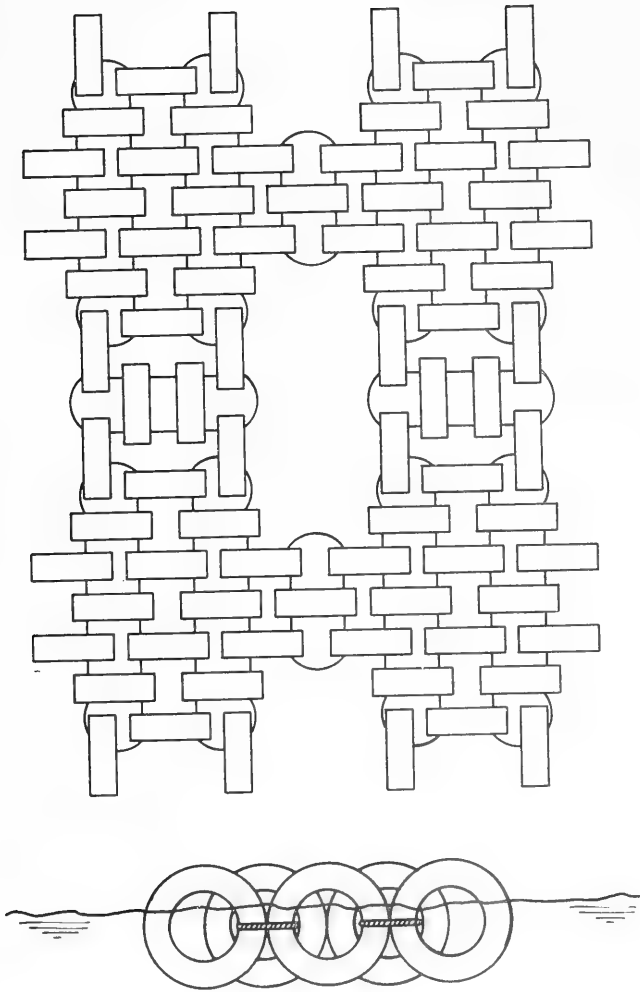
Figure 1. Goodyear FTB--top view of four connected modules (scale - 1:44, spacing between tires exaggerated) and side view of single module (scale - 1:32).

One of the earliest FB designs was the Goodyear Floating Tire Breakwater, conceived by Richard Candle of the Research Division, Goodyear Tire and Rubber Company, as an outgrowth of his automobile crash barrier research. The Goodyear FTB is, in its simplest form, a flexible mat of tires riding the surface of the water. The earmark of this design is the Goodyear module--a set of 18 tires coupled in a 3-2-3-2-3-2-3 vertical fashion (Fig. 1). These modules are bound parallel to one another to form a checkerboardlike mat of whatever dimensions the designer deems necessary for the site.

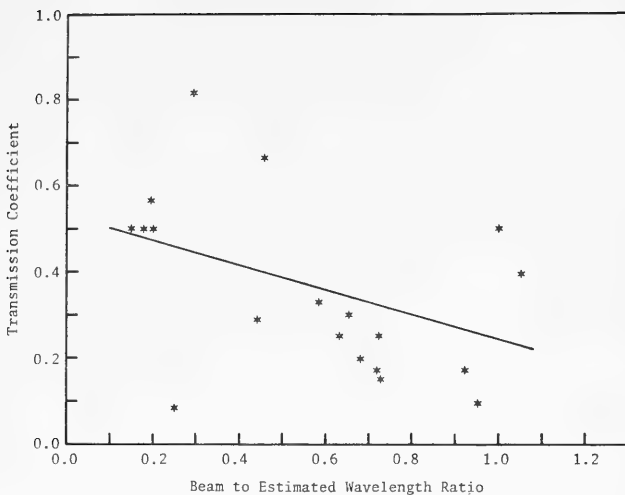
Figure 2. Reported effectiveness of the Goodyear FTB as a function of the ratio of the structure's beam to the estimated length of an incident storm wave.

One of the indicators of an FTB's likely effectiveness in reducing wave height is the ratio of the structure's beam to the length of an incident wave. In theory and as borne out in model tests, as this ratio increases (i.e., as the FTB spans more and more of the wavelength), the effectiveness of the structure likewise improves. To determine if this trend was substantiated by field experiences, MRM plotted the reported transmission coefficients versus the beam to estimated wavelength ratios (see Fig. 2). While there is considerable scatter in the points, the trend is clear as illustrated by a line fitted by the least squares method. This trend agrees with theory. Generally speaking, those FTBs which were most successful were located at sites with reported conditions such that the FTB's beam equaled or exceeded 60 percent of the length of a typical storm wave (see Harms, 1979)<sup>2</sup>.

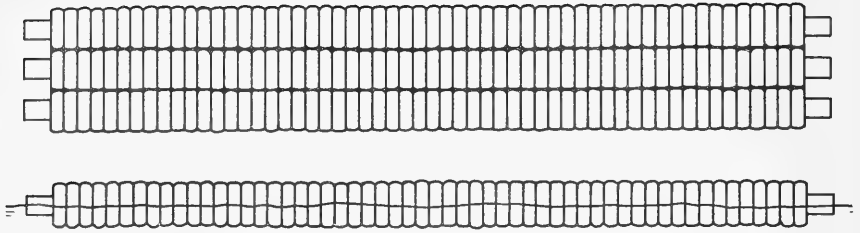
Figure 3. Pole-tire FB--top and side view of single module (scale - 1:84).

Five FB designs radically different from the Goodyear concept were uncovered in the survey of FBs in the Eastern United States. These designs are the pole-tire FB (Fig. 3), the timber caisson FB (Fig. 4), the steel pipe FB (Fig. 5), the steel caisson FB (Fig. 6), and the log boom FB (Fig. 7). In all five cases, only one site was found for each design; consequently, there is no substantial statistical base from which to draw general conclusions.

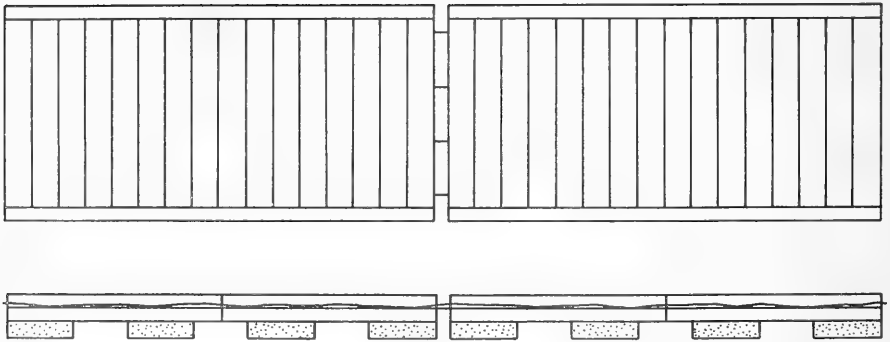
Figure 4. Timber caisson FB--top and side view of two connected modules (scale - 1:78).

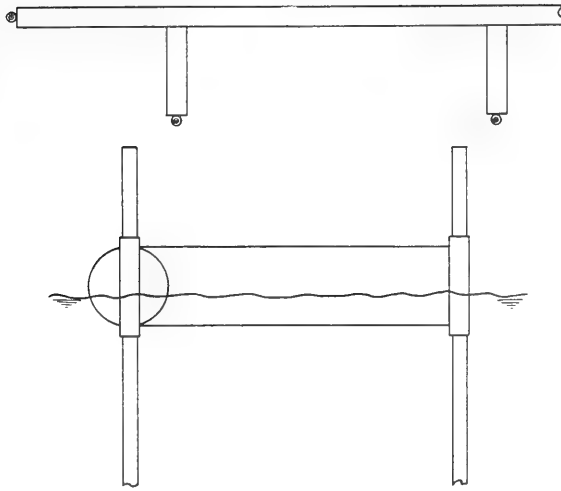
Figure 5. Steel pipe FB--top view of far section (scale - 1:156) and side view (scale - 1:40).

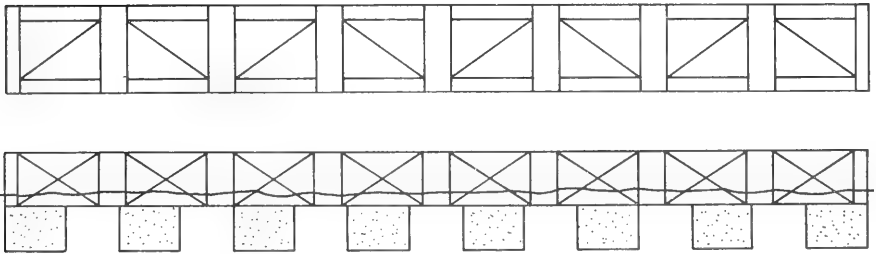
Figure 6. Steel caisson FB--top and side view of single module (scale - 1:78).

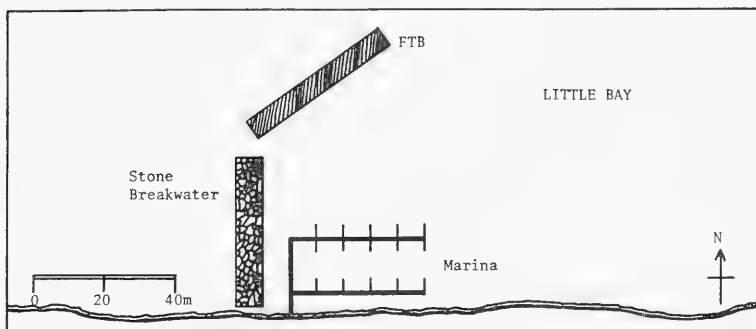
**Site:**

**Construction:** This FTB is 45.7 m (150.0 ft) in length and 6.4 m (21.0 ft) in width. Flotation relies on air trapped in the tire crowns and is aided by polyethylene blocks inserted in some of the tires. Rubber conveyor belting fastened with nylon bolts is used to couple the tires.

**Installation:** The breakwater is fastened at its southern tip to the fixed stone breakwater, elsewhere it is anchored in place. Seven anchoring points are located around the perimeter of the breakwater. The anchors are 1,589-kg (3,500 lb) stone blocks. Mooring lines are of nylon/chain.

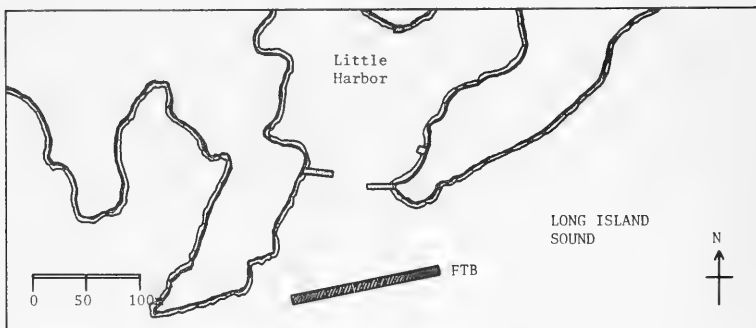
Site:

Construction: This FTB is 137.2 m (450.0 ft) in length and 9.1 m (30.0 ft) in width. The original structure relied on polyethylene blocks inserted in the tire crowns for proper flotation. After reconstruction, the breakwater relied on polyethylene scrap sealed in the tires by wire mesh and polyurethane foam for adequate buoyancy. Rubber conveyor belting fastened by nylon bolts was used to couple the tires. The operator noted that punching holes in the conveyor belting and tightening the belts was difficult.

Installation: The first structure was moored to fourteen 23 kg (50 lb) danforth anchors with ten anchors positioned on the exposed side and four on the leeward side. Mooring lines were of nylon/chain and were 27.4 m (90.0 ft) in length. The reconstructed FTB was moored by a system including eight 91 kg (200 lb) danforth anchors, eight 227-kg (500 lb) cement blocks, one 726-kg (1,600 lb) Navy stockless anchor, and one 908-kg (2,000 lb) Navy stockless anchor. Each anchor was also fitted with 6.1 m (20.0 ft) of one inch steel link chain, weighing 91 kg (200 lb). Mooring lines were of 0.75-inch nylon and were 27.4 m (90.0 ft) long.

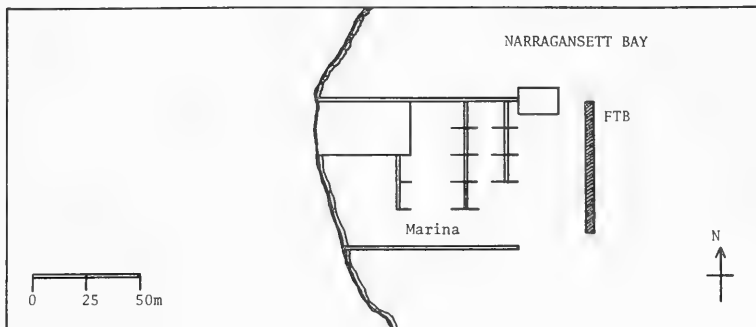
**Site:**

**Construction:** This FTB is 61.0 m (200.0 ft) long and 3.7 m (12.0 ft) wide. Primary flotation originally relied on air trapped in the tire crowns. After sinking in 1977, the FTB was retrofitted with polyethylene blocks inserted in the tires. Rubber conveyor belting fastened by nylon bolts is used to couple the tires. Rope is used to couple the modules.

**Installation:** The breakwater is anchored to four 908-kg (2,000 lb) concrete blocks spaced evenly along the structure's exposed side. Mooring lines are of chain and are 22.9 m (75.0 ft) in length.

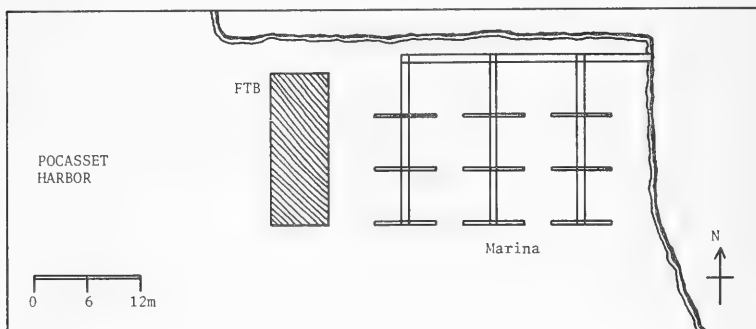
Site:

Construction: This FTB is 17.1 m (56.0 ft) in length and 6.4 m (21.0 ft) in width. Originally, the breakwater relied on trapped air for flotation and on a variety of experimental materials, including rope, chain, and stainless-steel cable, for coupling. This structure lasted approximately 2 years before the couplings failed and flotation became a major problem. The reconstructed unit uses rubber conveyor belting fastened with nylon bolts as the coupling material. Polyurethane foam poured into the tire crowns now provides primary flotation. The only problem encountered in constructing the breakwater was difficulty in drilling through the belting.

Installation: The breakwater is anchored by five 909-kg (2,000 lb) concrete blocks. Three of the anchors are positioned on the exposed side of the structure and two on the leeward side. Mooring lines are of nylon/chain and are 4.3 m (14.0 ft) in length.

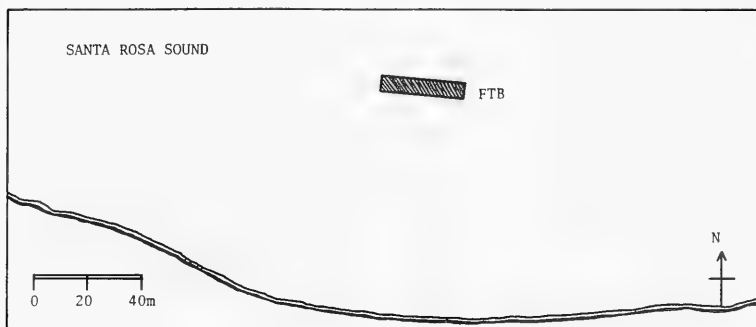
Site:

in the tire bases. Holes, 1.5-inch diameter, were drilled in the truck tire bases to prevent sand from accumulating in them. It was also hoped that the high sidewalls of the larger tires would aid in keeping out sand. Because the tires were substantially exposed at low tide, flotation relied solely on air trapped in the tire crowns. Rubber conveyor belting coupled the tires and was fastened by tying the end of the belting into square knots.

Installation: The breakwater was moored by six 11 kg (25 lb) danforth anchors placed at each corner and in the middle of each end. The mooring lines were of 0.5-inch nylon and were 9.1 m (30.0 ft) in length.

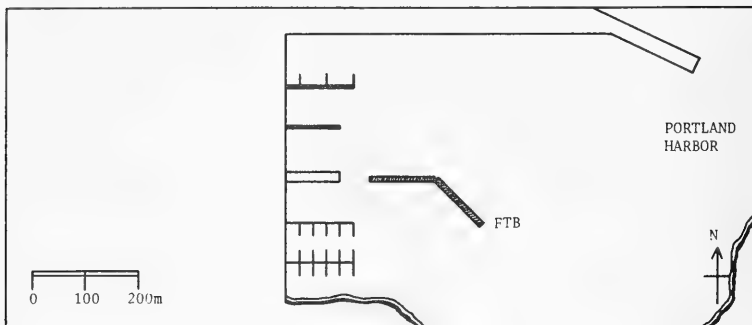
Site:

Construction: This FTB is 243.8 m (800.0 ft) in length with half the structure 10.7 m (35.0 ft) wide and the remainder 6.4 m (21.0 ft) wide. Primary flotation relies on air trapped in the tire crowns. Rubber conveyor belting fastened by bolts is used to couple the tires.

Installation: The breakwater is tied to pilings by rubber conveyor belting. On the structure's exposed side, the pilings are spaced 15.2 m (50.0 ft) apart and on its leeward side, 30.5 m (100.0 ft) apart.

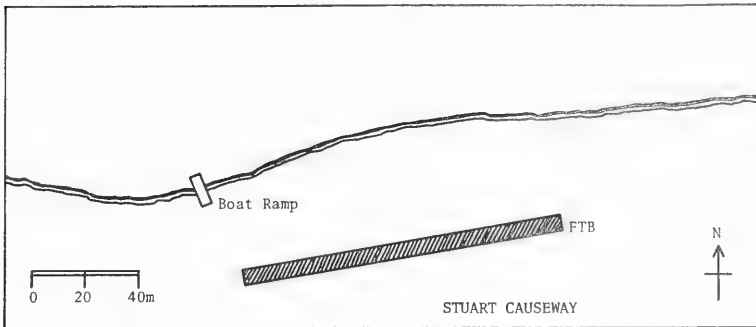
**Site:**

**Construction:** The first unit was 118.9 m (390.0 ft) in length and 6.1 m (20.0 ft) in width. Primary flotation relied on polyethylene blocks inserted in the tire crowns. The tires were coupled by polypropylene rope. The reconstructed structure was also 118.9 m (390.0 ft) in length, but only 4.0 m (13.0 ft) in width. Primary flotation was derived from polyurethane foam poured into the tire crowns. Steel cable, 3/8-inch diameter, was used to couple the tires.

**Installation:** The original structure was moored to 10 danforth anchors. Seven anchors were spaced evenly along the exposed side of the FTB and three were spaced uniformly on the leeward side. Mooring lines were of 3/8-inch steel cable and were 9.1 m (30.0 ft) long. The second breakwater used the same mooring configuration and same type of mooring line, but employed tiedown-type helix anchors in place of the danforths.

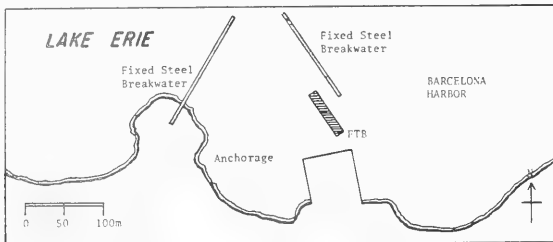
**Site:**

**Construction:** This FTB was 61.0 m (200.0 ft) in length and 17.1 m (56.0 ft) in width. Primary flotation relied on air trapped in the tire crowns. Rubber conveyor belting fastened by bolts was used to couple the tires. A volunteer work force was used to build the breakwater and this resulted in inconsistent and poor-quality construction.

**Installation:** The breakwater was anchored to 1,634-kg (3,600 lb) concrete blocks. On the structure's exposed side, the blocks were spaced 4.3 m (14.0 ft) apart and on its leeward side, 8.5 m (28.0 ft) apart. Mooring lines were of chain and were 12.2 m in length.

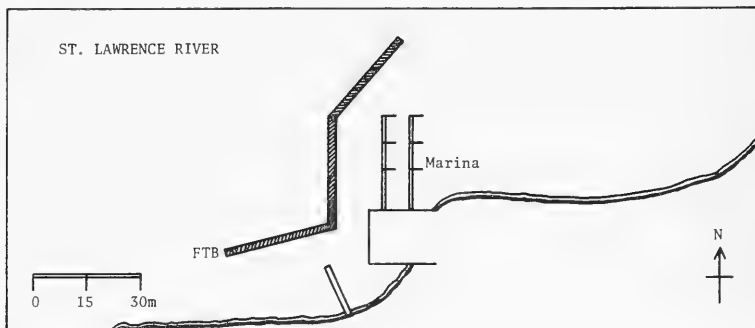
Site:

Construction: This FTB is 91.4 m (300.0 ft) in length and 1.8 m (6.0 ft) in width. Flotation relies solely on air trapped in the tire crowns. Rubber conveyor belting fastened with stainless-steel bolts is used to couple the tires.

Installation: The breakwater is tied to pilings by conveyor belting on its leeward side and anchored on its exposed side. The pilings are spaced 3.0 m (10.0 ft) apart. The anchors are 227-kg (500 lb) concrete blocks and are spaced 7.6 m (25.0 ft) apart. Anchor lines are of chain and are 6.1 m (20.0 ft) long. The builder noted that transporting the breakwater from its inland construction site to the water was a very difficult undertaking.

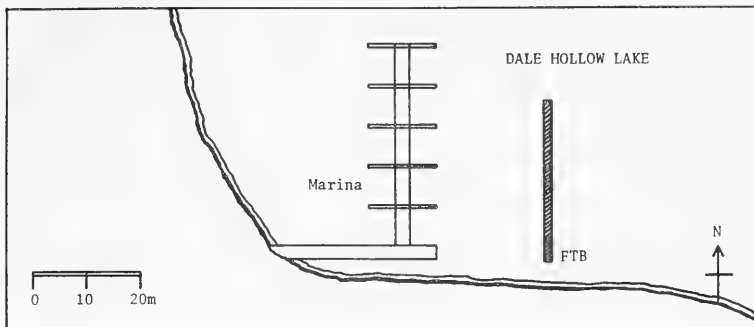
Site:

Construction: This FTB is 30.5 m (100.0 ft) in length and 1.8 m (6.0 ft) in width. Flotation relies on air trapped in the tire crowns. Nylon strapping fastened by banding clamps is used to couple the tires.

**Installation:** The breakwater is moored by two anchors located at the extreme ends of the structure. Each anchor is a 55-gallon drum filled with concrete. The mooring lines are of wire rope and are 24.4 m (80.0 ft) in length.

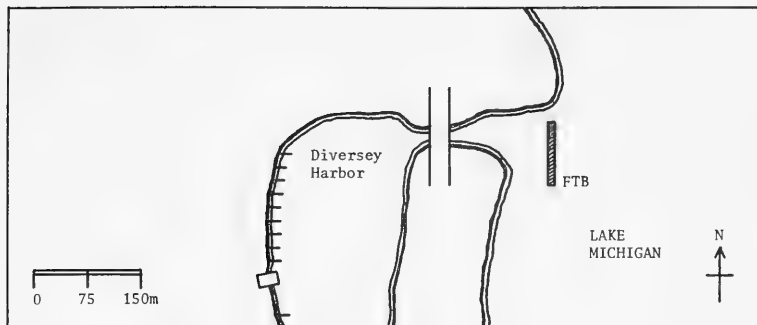
Site:

Construction: This FTB was 91.4 m (300.0 ft) in length and 8.5 m (28.0 ft) in width. Primary flotation was derived from both polystyrene blocks inserted in the tire crowns and polyurethane foam poured into some of the tires. Chain fastened by clamps was used to couple the tires.

**Installation:** The breakwater was anchored by twenty 1,226-kg (2,700 lb) concrete blocks. On the structure's exposed side, the anchors were spaced 7.6 m (25.0 ft) apart and on its leeward side, 15.2 m (50.0 ft) apart. Mooring lines were of chain and were 10.4 m (34.0 ft) in length.

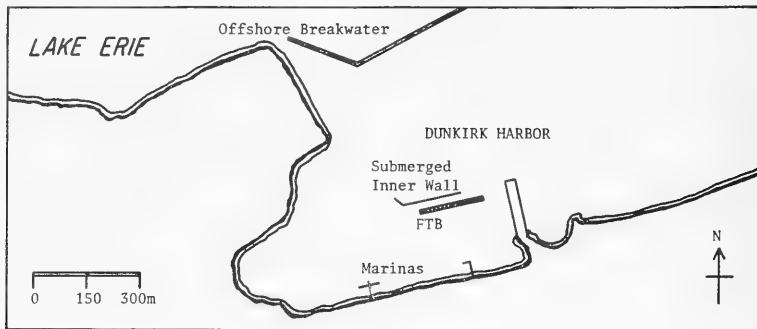
**Site:**

**Construction:** The original FTB was 182.9 m (600.0 ft) in length and 8.5 m (28.0 ft) in width. This FTB's flotation relied solely on air trapped in the tire crowns. Stainless-steel wire was used as the coupling material. When reconstructed, the FTB was extended to 304.8 m (1,000.0 ft) in length. Polyethylene blocks were inserted in the tires to aid flotation and open link Campbell chain replaced the stainless-steel wire.

**Installation:** The breakwater was initially anchored by 24 cylindrical-shaped 272-kg (600 lb) cement blocks. These were found to roll on the bottom during strong wave action and so were replaced by a like number of rectangular-shaped cement blocks. Mooring lines were of chain and were 19.5 m (64.0 ft) in length.

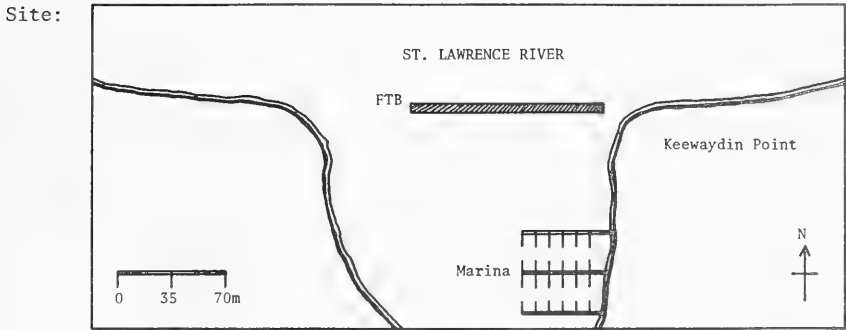
**Construction:** This FTB is 121.9 m (400.0 ft) in length and 5.9 m (19.5 ft) in width. Primary flotation is derived from polyurethane foam poured into the crowns of the tires. Rubber conveyor belting fastened with nylon bolts is used to couple the tires. The only problem encountered in the design stage was the public's reluctance to accept the project due to their anticipation that the FTB would have an unsightly effect on the waterfront. The operator noted that this bias vanished once the structure was deployed.

**Installation:** The breakwater is tied to pilings on both its exposed and sheltered sides and anchored also on its leeward side. The pilings are spaced 18.3 m (60.0 ft) apart. The anchors are 136-kg (300 lb) concrete blocks and are spaced 15.2 m (50.0 ft) apart. Mooring lines are of chain and are 30.5 m (100.0 ft) in length.

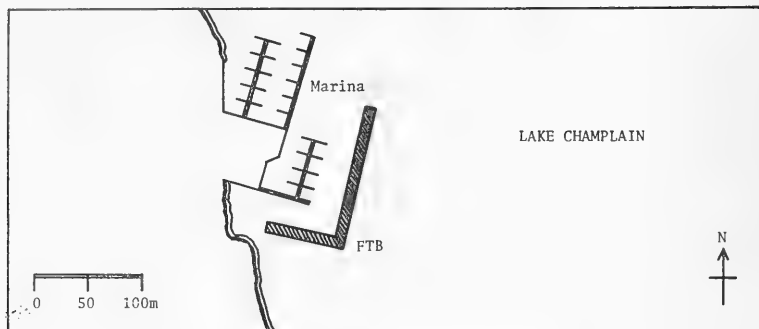
**Site:**

**Construction:** This FTB is 198.1 m (650.0 ft) long and 9.1 m (30.0 ft) wide. Flotation relies on air trapped in the tire crowns and is aided by polyethylene blocks inserted in some of the tires. A 3/8-inch-high test chain bolted together is used to couple the tires.

**Installation:** The breakwater is moored by 45 kg (100 lb) mushroom anchors on its leeward side and 363-kg (800 lb) to 454-kg (1,000 lb) railroad wheels on its exposed side. The anchors are spaced 30.5 m (100.0 ft) apart. Mooring lines are of chain-wire and are 18.3 m (60.0 ft) long.

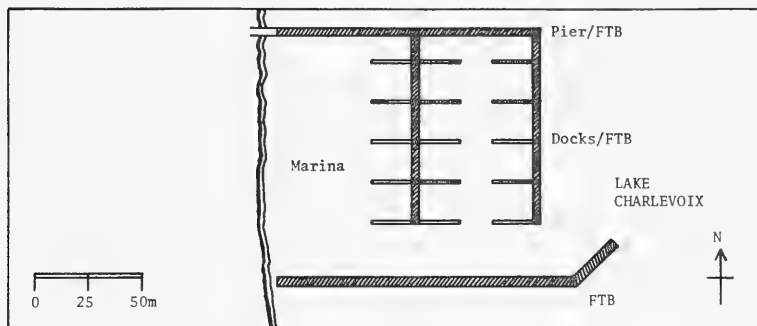
Site:

with two dock-breakwater extensions each 91.4 m (300.0 ft) long. Enclosing the southern side of the marina is a second FTB, 161.6 m (530.0 ft) long. The width of these units is 3.7 m (12.0 ft). Primary flotation is derived from polyurethane foam poured into the tire crowns. Rubber conveyor belting fastened with bolts is used to couple the tires.

**Installation:** The breakwaters are both tied to pilings and anchored by 9 kg (20 lb) danforth anchors. Anchors and pilings are spaced from 3.0 m (10.0 ft) to 3.7 m (12.0 ft) apart. Mooring lines are of wire rope and vary from 3.0 m (10.0 ft) to 18.3 m (60.0 ft) in length.

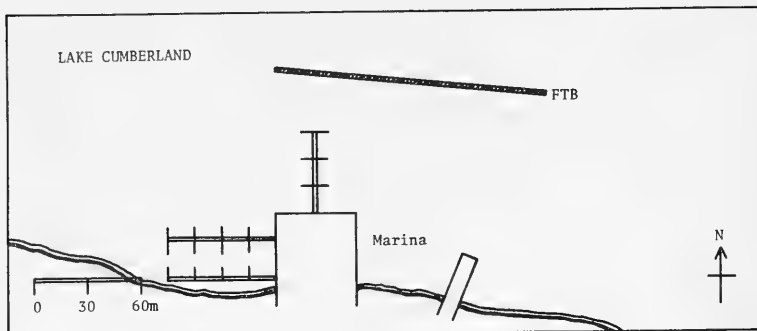
Site:

Construction: This FTB is 152.4 m (500.0 ft) in length and 1.8 m (6.0 ft) in width. Primary flotation is derived from polyethylene blocks inserted in the tire crowns. The tires are coupled together with 0.25-inch cable fastened with clamps. The cable and clamps are of stainless steel due to the acidic nature of the water.

Installation: On its exposed side, the structure is moored by several 454-kg (1,000 lb) anchors. On its leeward side, the breakwater is moored to the shore via three concrete-filled barrels. Mooring lines are of stainless steel wire and are 91.4 m (300.0 ft) in length.

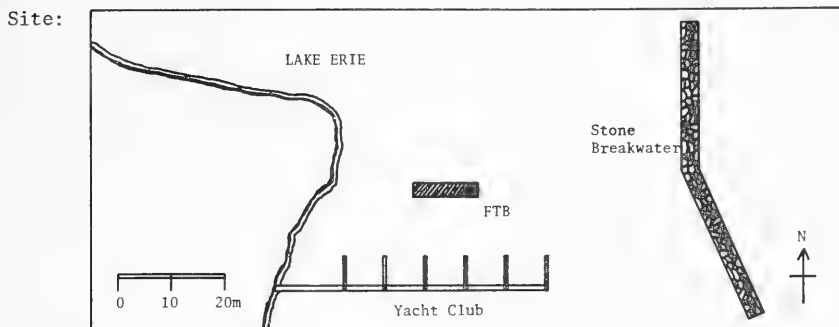
Construction: A pole-tire module consists of three telephone poles coupled parallel to one another by channel and threaded rod. Each pole is skewed with tires held in place by cable. Flotation relies on the

inherent buoyancy of the wooden poles. The prototype consisted of a single module and was 12.2 m (40.0 ft) in length and 2.4 m (8.0 ft) in width.

**Installation:** The breakwater is anchored by four 227-kg (500 lb) concrete blocks. The mooring points are located at the corners of the structure. The mooring lines are of chain.

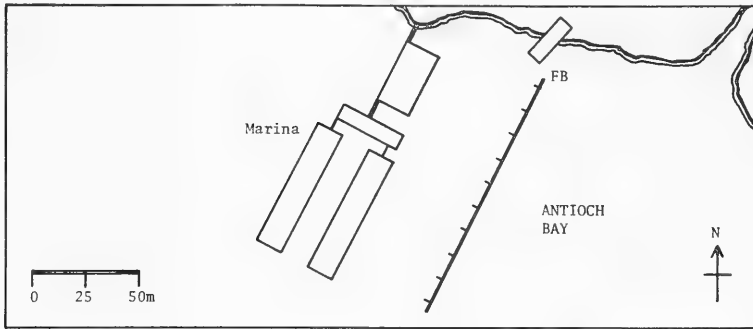
Site:

Ten 3.0-m (10.0 ft) steel fingers extend from the pipe and grasp the 4-inch diameter spudpoles by means of 0.9-m (3.0 ft) -long brackets made from 5-inch pipe.

**Installation:** The breakwater is free to slide up and down the spudpoles. Ten spudpoles are positioned on the leeward side of the structure at 12.2-m (40.0 ft) intervals. There is also a spudpole at each end of the breakwater.

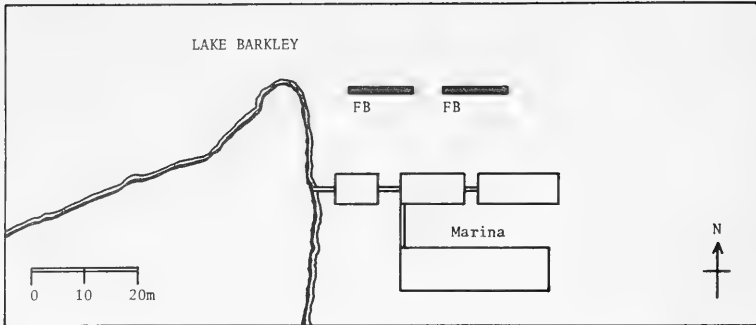
Site:

Installation: Each module is moored to five 50-gallon metal drums filled with concrete. Mooring lines are of wire cable and are 18.3 m (60.0 ft) in length.

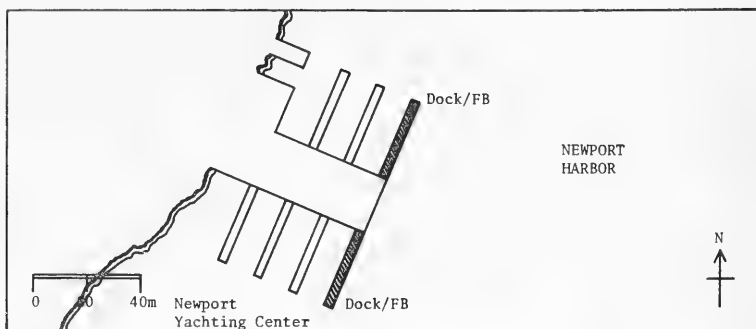
Site:

Construction: Each timber caisson module is 6.1 m (20.0 ft) long and 3.0 m (10.0 ft) wide. In design, this FB is essentially a deep draft floating dock. It is constructed of timber with primary flotation provided by large polyethylene blocks. Modules are coupled together by steel rods held fast by bolts. The finished breakwater will be in two sections, each five modules long.

Installation: The breakwater will be tied to pilings. On the structure's exposed side, the pilings will be spaced 6.1 m (20.0 ft) apart and on its leeward side, 12.2 m (40.0 ft) apart.

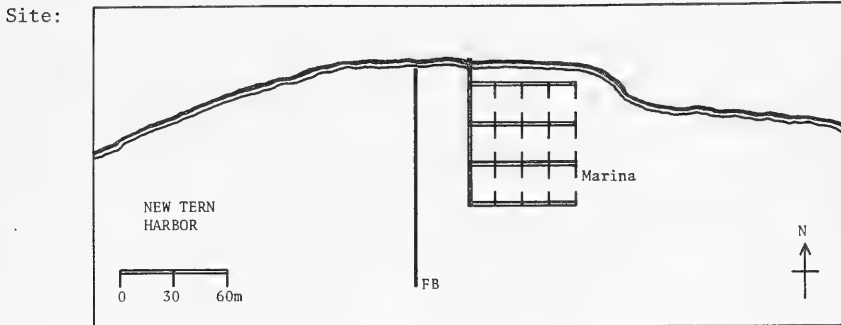
Construction: The present operator inherited the log boom from the previous owner and is unaware of any problems arising during construction. The breakwater was once 121.9 m (400.0 ft) long, though it is now only 51.8 m

(170.0 ft) long. It is one log or 0.6 m (2.0 ft) wide. Flotation is aided by a few tires and some polyethylene blocks tied to the structure. Chain is employed to couple the logs.

Installation: The breakwater is anchored to several large concrete blocks. Mooring lines are of chain and are 3.7 m (12.0 ft) to 4.6 m (15.0 ft) long.
